ROTOR MACHINING & RESURFACING

Resurfacing rotors may be simple, but as with any other machining process you should be aware of why you are doing it and how to do it correctly.

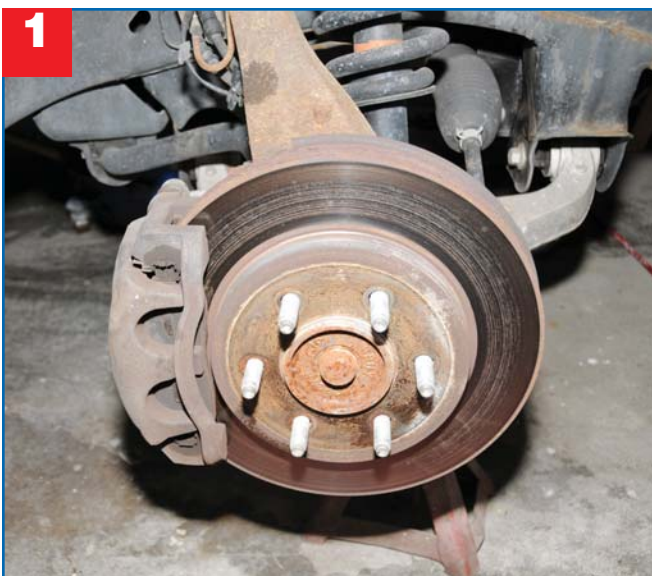
This brake system has pulsation present, and the rotors have been machined before to eliminate that problem. Perhaps you should find out the reason for the pulsation before turning the rotors. Note the amount of transfer material on the rotor surface.

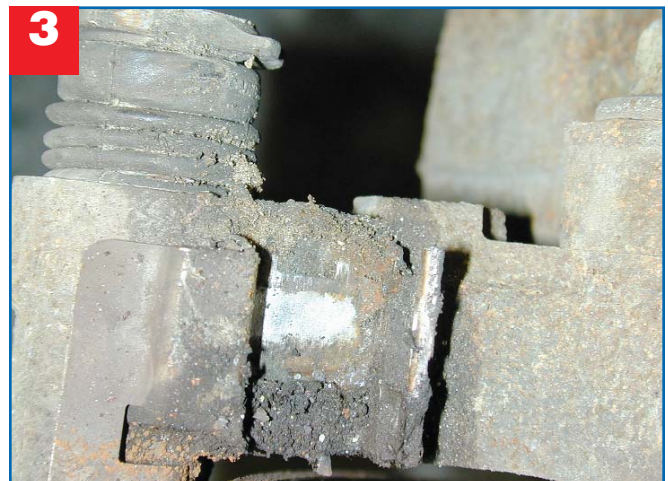
This is the area where the pad contacts the hardware. There has been adequate lubrication and there is no restriction of pad movement in this area, so you can eliminate that as a possible cause.

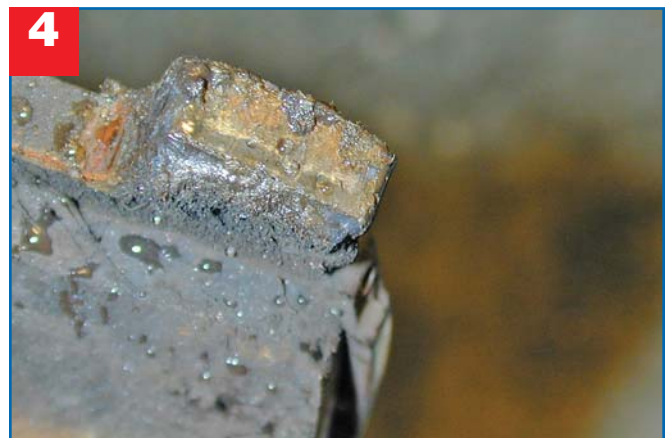
Looking at the edge of the pad shows that it has been moving and was not rusted in place.

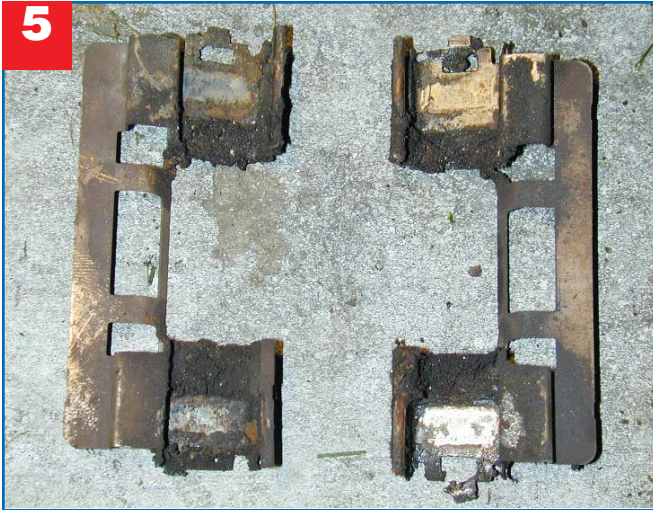
5 Rust and scale buildup on these pad clips is not excessive.

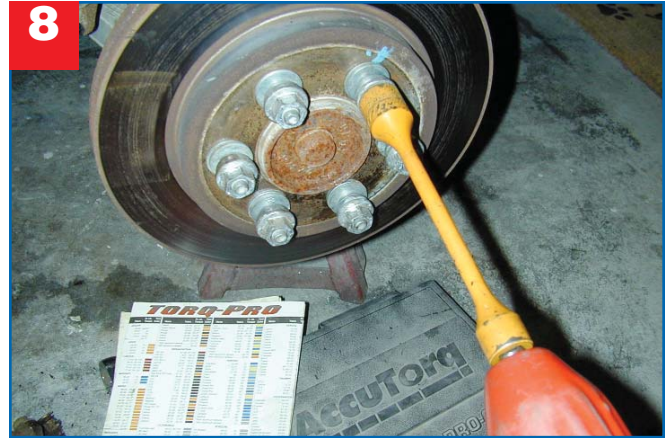
8 This is the first step in indexing a rotor to check runout. The special washers weren't available, so the technician used large flat washers that accepted the tapered end of the lug nuts. Using a torque stick, he torqued all six lug nuts onto the rotor.

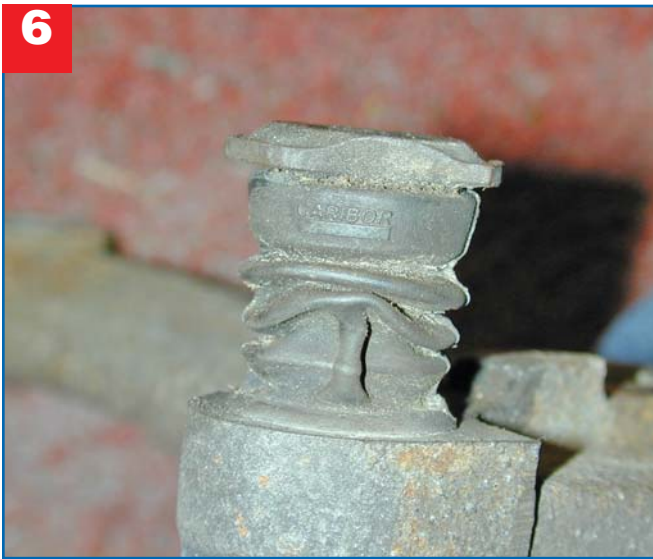
6 When the caliper pin is slid outward, it is evident that the boot is dimpled inward. If you don't notice this condition, a torn boot can result.

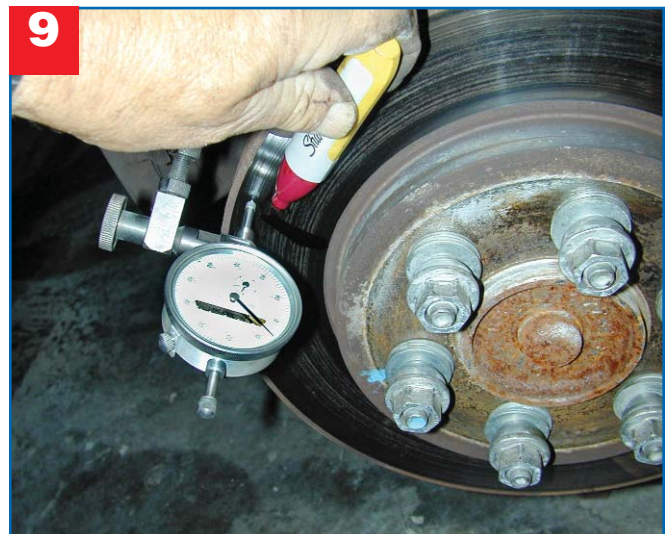
9 The dial indicator is set up and zeroed in to the reference mark on the rotor.

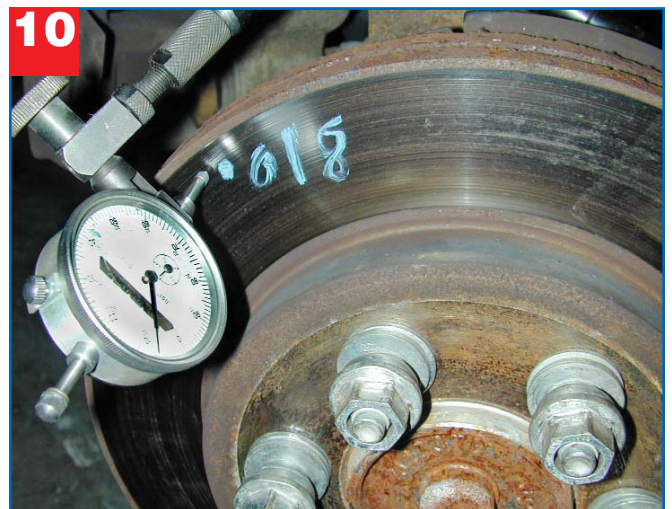
10 The rotor then is rotated one complete turn and the high point of runout is noted. You must know the amount of runout and where it is to mount the rotor on the lathe correctly.

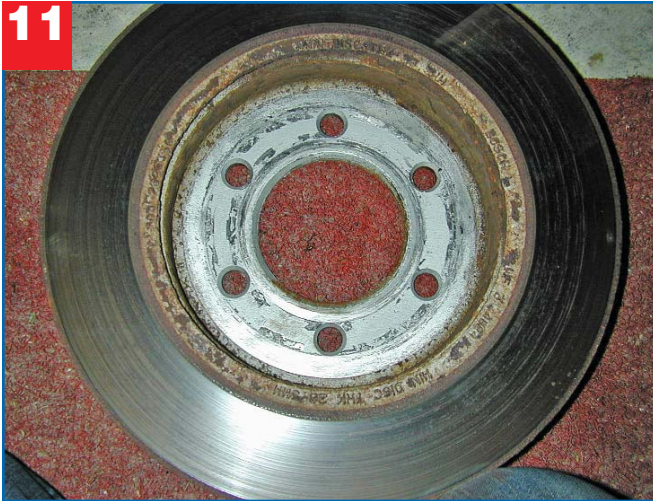
11
The inside of the rotor hat is still coated with the lubricant applied the last time the rotor was serviced to keep rust and scale from building up.

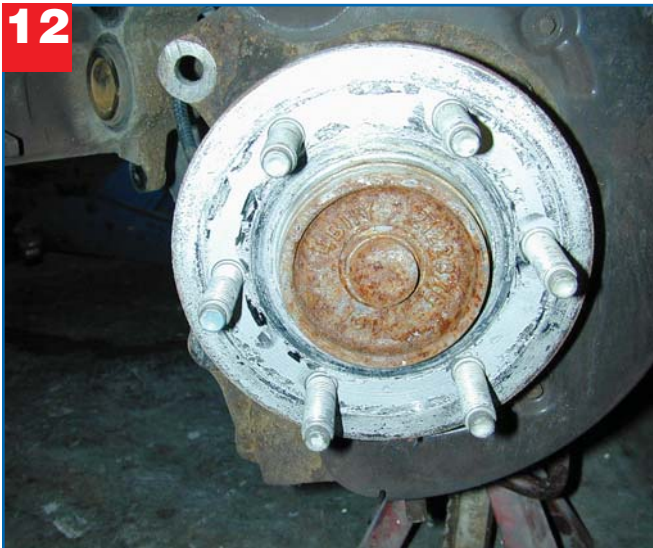
12
Note the coating on the hub surface. Ford began lubricating hub surfaces on its trucks in the 2004 model year to prevent rust and scale, so this is an authorized procedure.

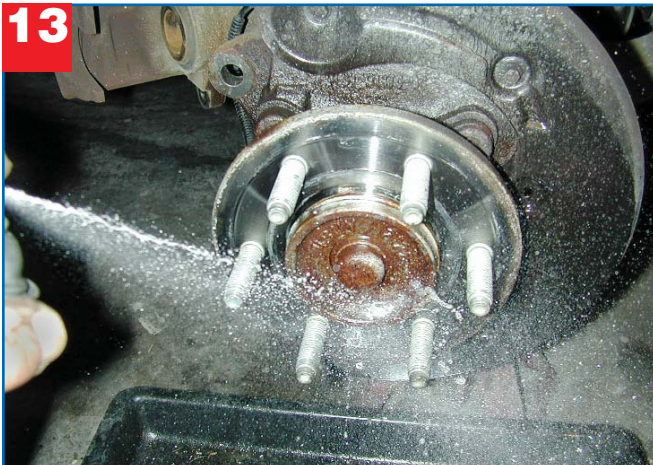
13
The hub face is being washed to remove the anti-corrosive coating so runout can be measured accurately.

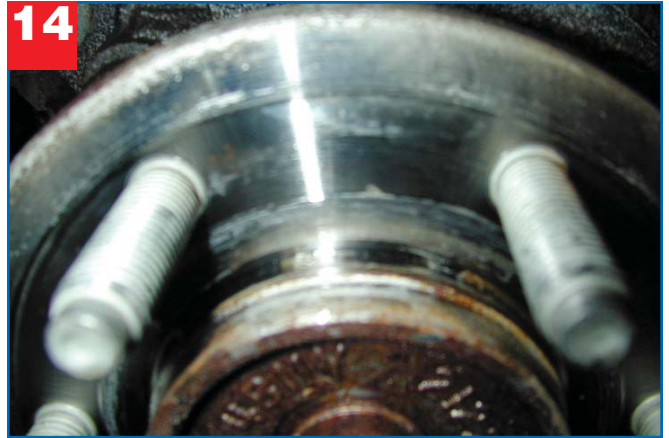
14
You can see that the lubricant has prevented rust on the hub face.

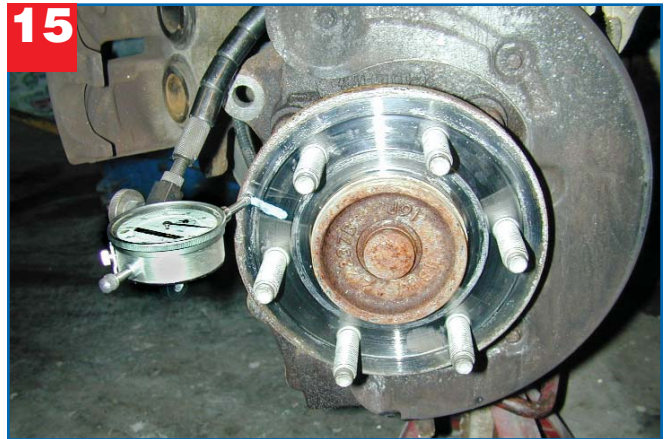
15
The dial indicator is set up to check runout on the hub face. The needle did not move noticeably during a complete revolution of the hub, so the runout did not result from stacked tolerances caused by the hub face.

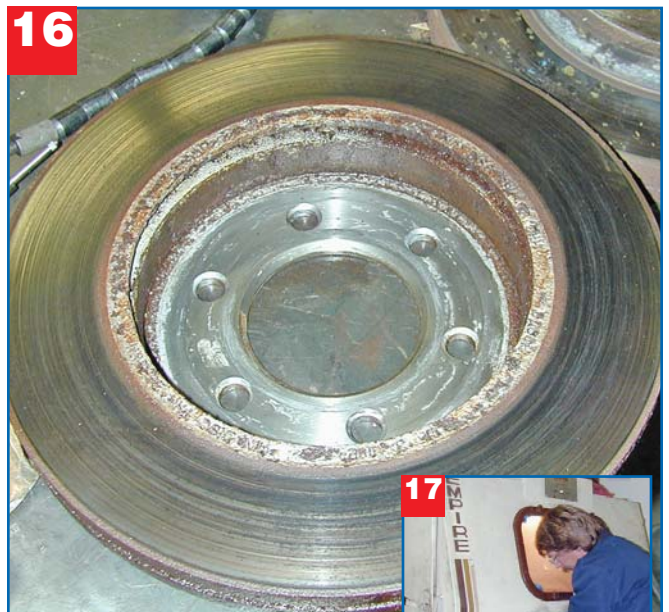
16
Because the rotor had considerable rust and scale in non-contact areas, it was cleaned in a blasting cabinet before machining.

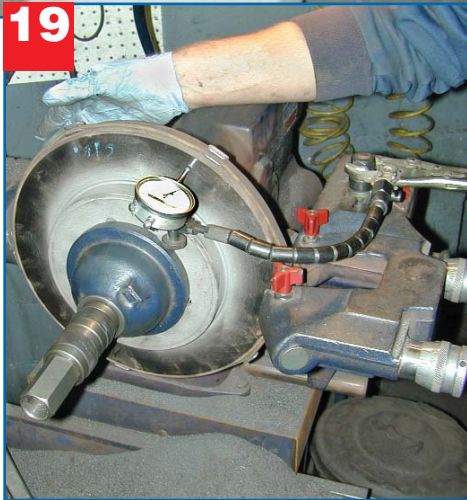
With the inside of the hat area cleaned, the rotor was mounted on the lathe and runout was measured. Loosening the spindle nut and rotating the rotor slightly matched runout on the lathe to that on the vehicle so the rotor could be machined properly.

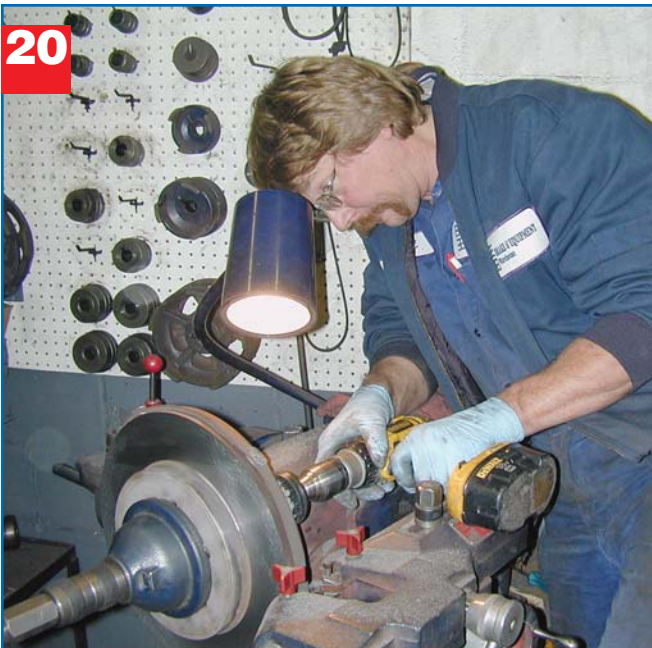
The final step in rotor resurfacing should be a non-directional finish. The hone being used here does an excellent job if you maintain the rotational speed of 100 rpm recommended by its manufacturer and apply even, moderate force.

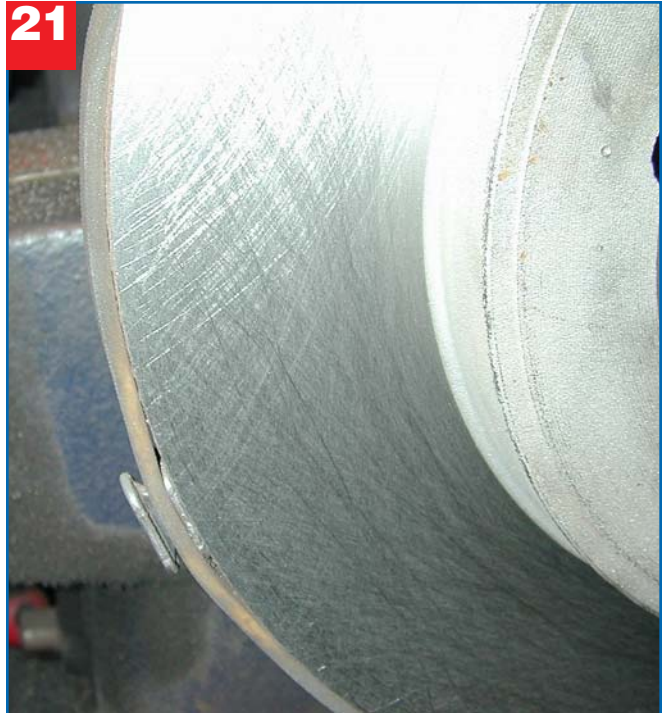
The reason for applying a non-directional finish is not to smooth a poorly machined rotor but to provide a surface on which the pads can seat properly.

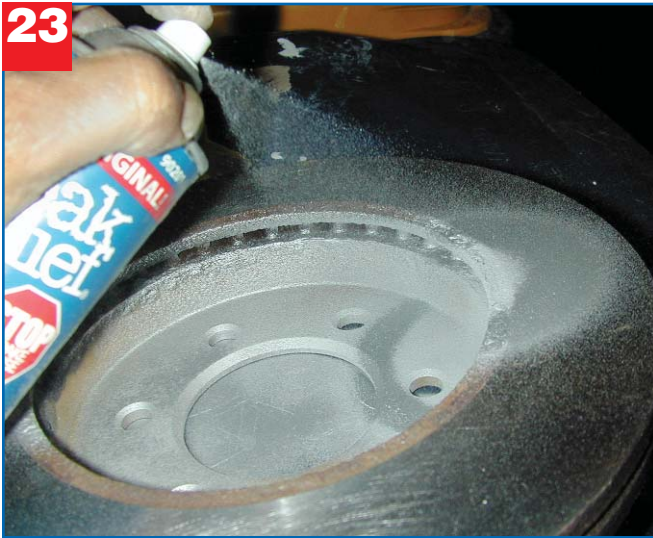
This product that is sprayed onto the rotor surface to help prevent brake noise also works well for preventing rust and scale on the inside of the hat. The spray coating adheres well to this area.

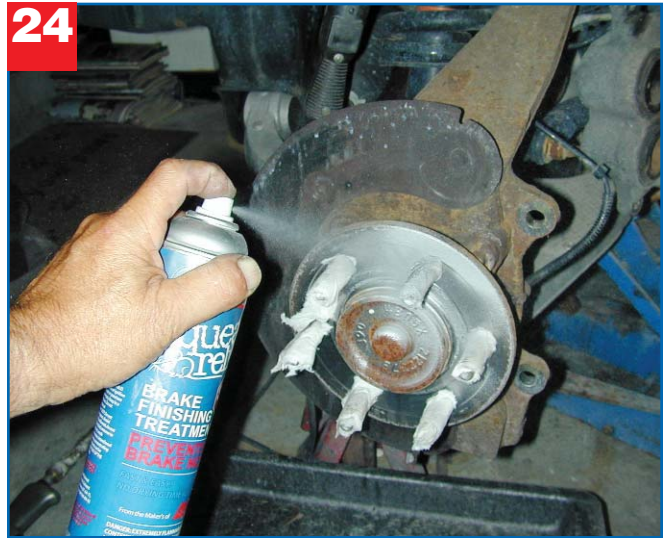
The same product is being used to coat the hub face to prevent rust. The studs have been covered so that the spray-on product won't act as a lubricant and interfere with proper torquing of the lug nuts. **UD**
